MEMORANDUM

SUBJECT: Public hearing and consideration of a Landmark Alteration Certificate application to add new round windows to the street facing gables of the contributing houses at 521 Maxwell Ave. in the Mapleton Historic District, per Section 9-11-18 of the Boulder Revised Code 1981 (HIS2016-00121).

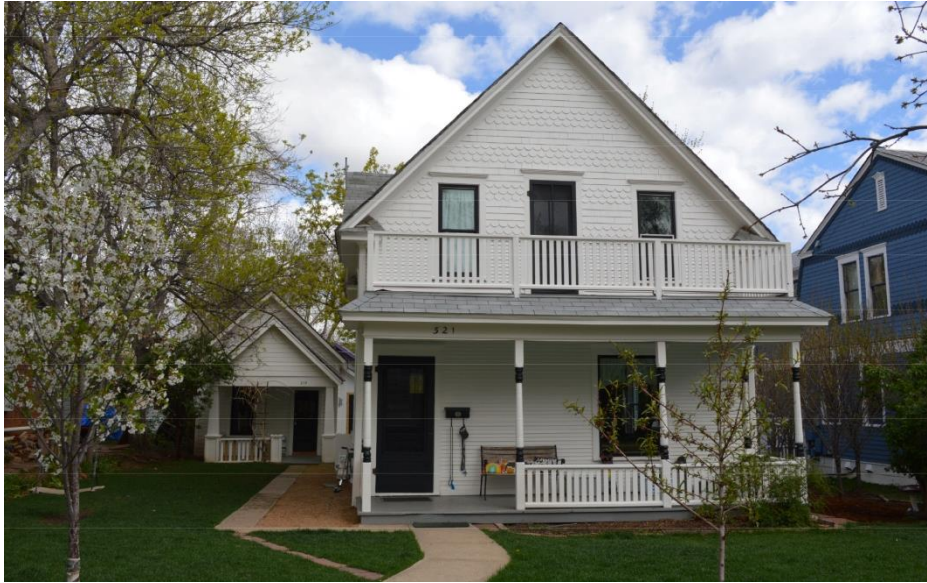
Figure 2. View of south elevation (façade) of primary house, 2016.

The one-and-a-half story wood frame main house on the property was constructed around 1900 and is an example of the type of Edwardian Vernacular house construction that was common in Colorado and around the United States at the turn-of-the twentieth century. Simply but elegantly detailed, it features a front facing gabled roof, fish scale wood shingles on the gables, clapboard and shingle siding, a full-width porch supported by turned spindles, and a full-width balcony above the porch.

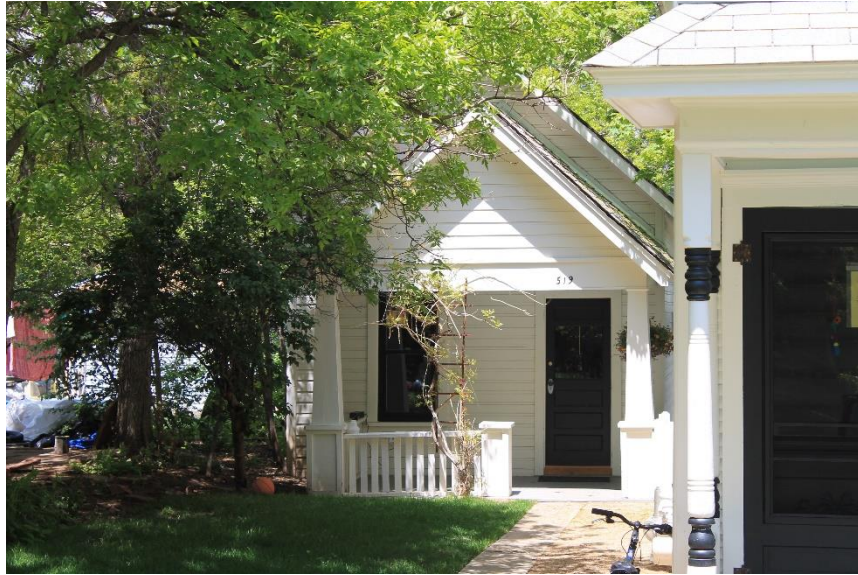
Figure 3. View of south elevation (façade) of secondary house, 2016.

The one-story wood frame secondary house, located behind the main house and along the west property line, was constructed around 1906 and is an example of simple, vernacular wood frame construction common in Boulder during the first half of the twentieth century. It features a front-gabled roof with overhanging eaves, a projecting front porch with shingled gable end supported by battered Arts and Crafts inspired wood columns on wood-paneled piers, and wood slat rail.

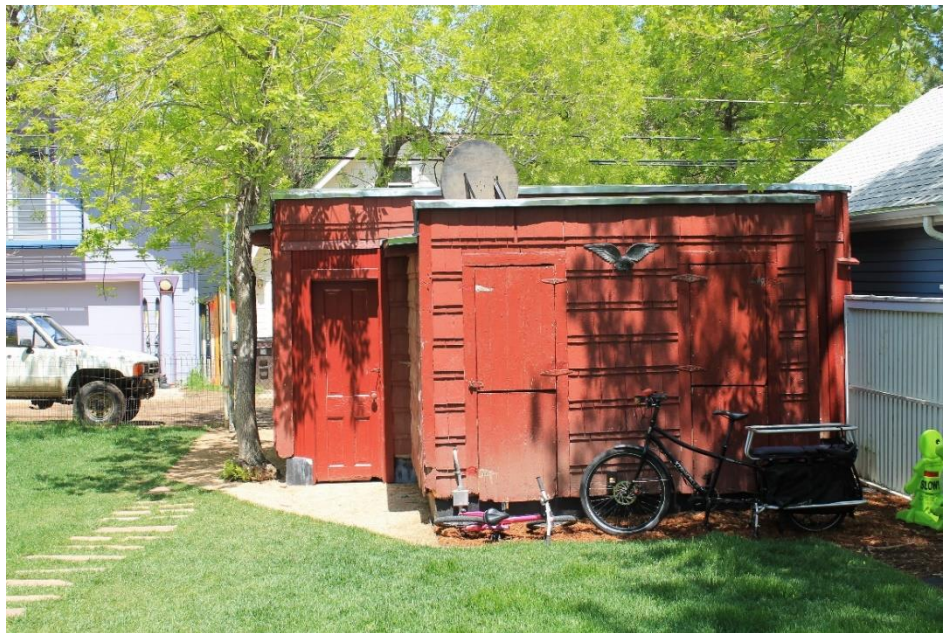
Figure 4. View of garage, 2016.

A wood frame flat roofed garage is situated at the north east corner of the property. Side-hinged vertical board doors face the alley on the north, and a pedestrian entry has been added to the south side. There is a four-light window on the west side. The Historic Building Inventory Record indicated the accessory building was likely constructed during the 1940's, due to its stylistic similarity to other nearby garages built during that period. No changes to this building are proposed.

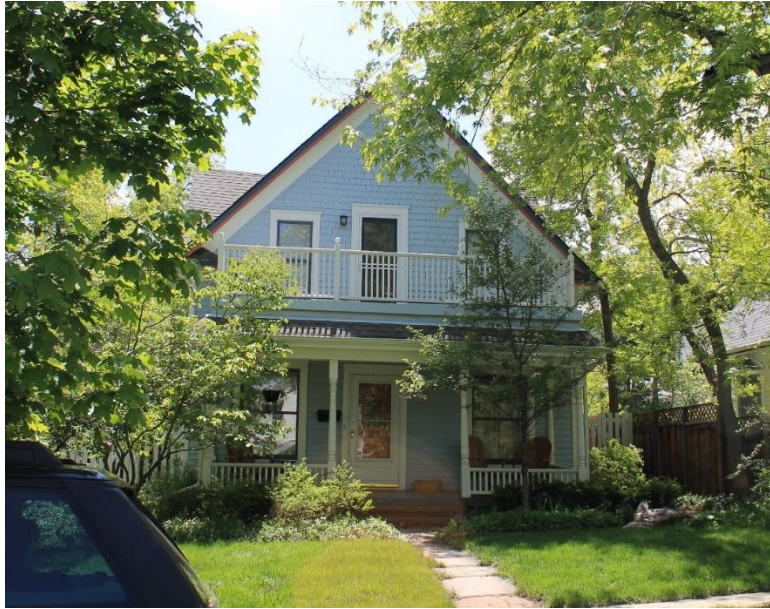
Figure 5. 520 Maxwell Avenue (across the street from 521 Maxwell Avenue), 2016.

Interestingly, the house directly across the street, 520 Maxwell Avenue, is nearly identical to the main house at 521 Maxwell Avenue and was likely constructed during the same period.

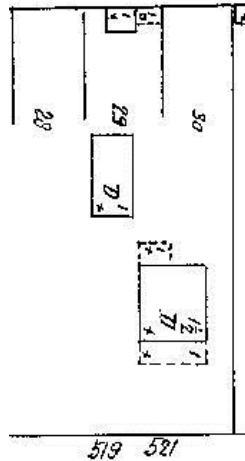
Building permit records show that the main house was repainted and reroofed in 1989. These same records show that the secondary house was sided with asbestos shingles in 1952. As of the 1993 survey these were still in place, but were recently removed, revealing the original wood siding. The 1909 Sanborn map, the first to cover this area of the city, shows both buildings much as they are today. The Sanborn map does not show the porch on the small house, indicating it may have been added after 1931. A number of sashes on both buildings have been replaced with vinyl windows, three of which were recently approved for replacement with wood sash replicating the historic windows more closely (HIS2016-00095). The only other notable alteration is the addition of a lean-to on the rear of the secondary dwelling, carried out sometime between 1922 and 1931.

Figure 8. 1906 Sanborn Map of 521 Maxwell Ave.

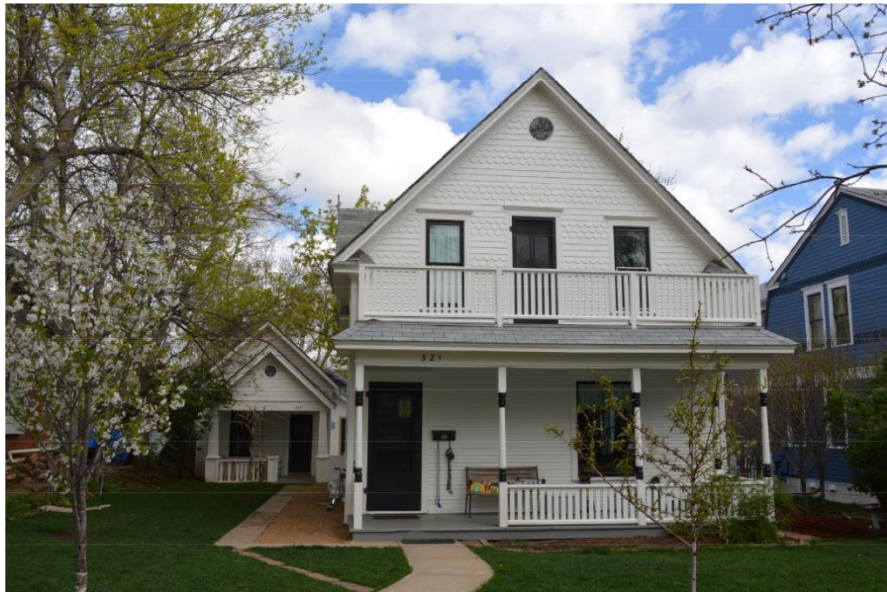
Plans call for the addition of a round window in the street-facing (primary elevation) gable ends of the main and secondary houses. Drawings show the window on the main house to be 1'6" in diameter, including frame. The proposed round window on the secondary house is shown to be similar in design to that proposed on the main house, though slightly smaller at 1', 3" in diameter. Both new windows are shown to be single light, wood-framed.

Figure 9. Proposed South Elevation (front), photo simulation.

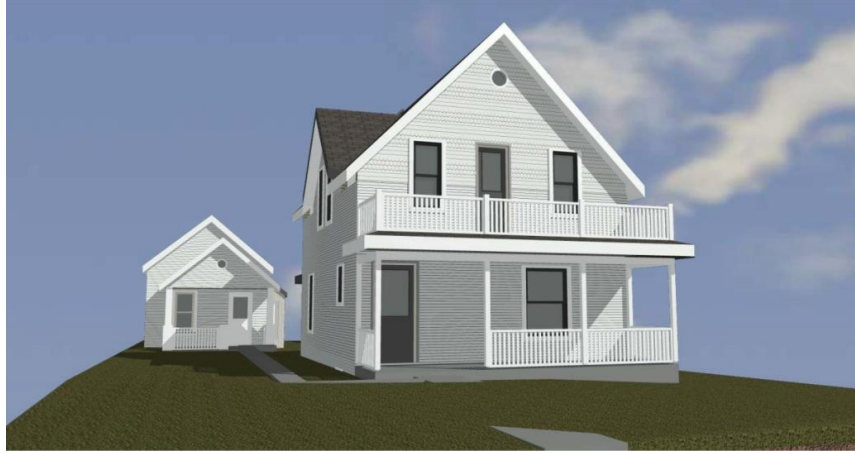
Figure 10. Proposed South Elevation (front), rendering.

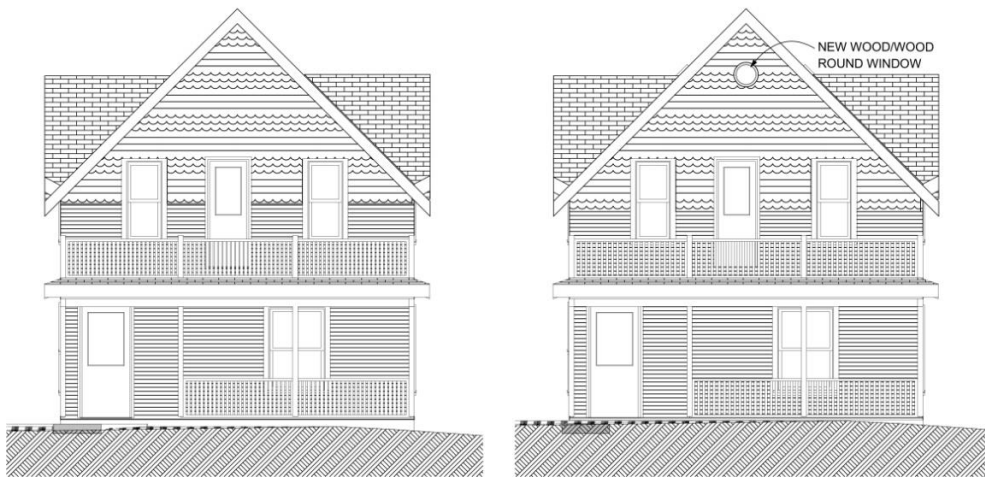
Figure 11. Existing (left) and Proposed (right) south elevations, main house.

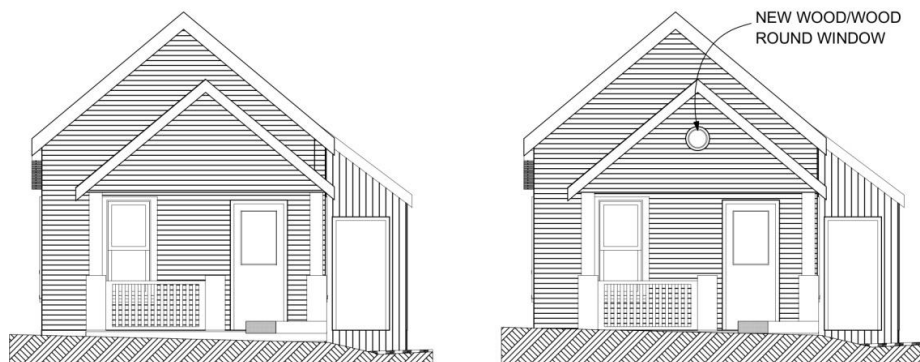
Figure 12. Existing (left) and proposed (right) south elevations, secondary house
